A Case Report of Valve Dysfunction Associated with Abrasion of the Delrin Disk Used in Early Björk-Shiley Mitral Valves Requiring Resurgery

Hidetoshi Masumoto, MD, Mitsuomi Shimamoto, MD, Fumio Yamazaki, MD, Masanao Nakai, MD, Shoji Fujita, MD, Yujiro Miura, MD, Tatsuya Itonaga, MD, and Hiroki Ito, MD

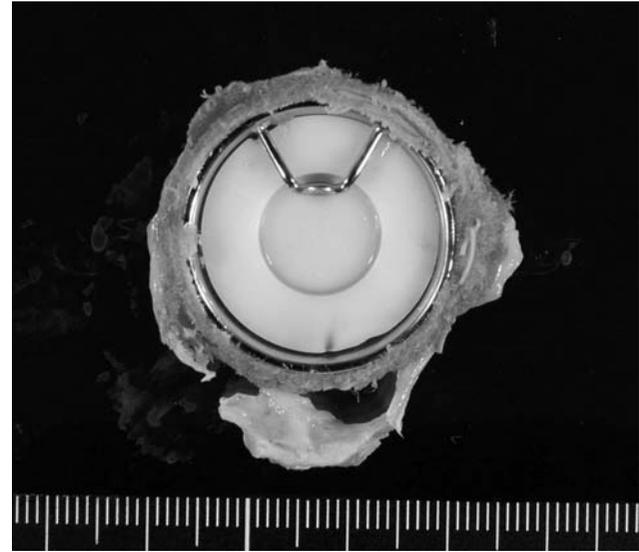
Surgical findings: The prosthetic mitral valve was observed. The entire Delrin disk was markedly abraded and partially striated (Fig. 1). The prosthetic valve was removed, and a new prosthetic valve (On-X 25 mm, Medical Carbon Research Institute, Austin, TX) was sutured. The aortic valve was observed. Because a perforation was noted in the left coronary cusp, regurgitation associated with it was diagnosed. The aortic valve was excised, and a prosthetic aortic valve (21-mm St. Jude Medical Regent, St. Paul, MN) was sutured to the supra-annular position.

Fig. 1. Photograph of the excised prosthetic mitral valve.

A maximum gap of 0.7 mm was present between the valve seat and the disk. Striation of the lower part was also noted.

In the valve excised from this patient, the maximum gap from the valve seat had been markedly increased to 0.7 mm (from the initial value of 0.18 mm) because of disk abrasion. This abrasion itself may have been the cause of regurgitation, but Mazzucco et al. reported that the disk moved excessively in the seat, promoting insufficiency.¹¹⁾ The disk was partially striated, as reported previously, which may have resulted from concentrated abrasion of the strut-contacting region, demonstrating that rotary motion securing the structural durability of the disk was lost. Since this striation was formed several years after the valve replacement,^{2,4)} the guaranteed duration of rotary motion after implantation is questionable.
