A Case of Early Failure of the Freestyle Stentless Bioprosthesis Due to Cuspal Tear

Key words: Freestyle stentless bioprosthesis, reoperation, cuspal tear

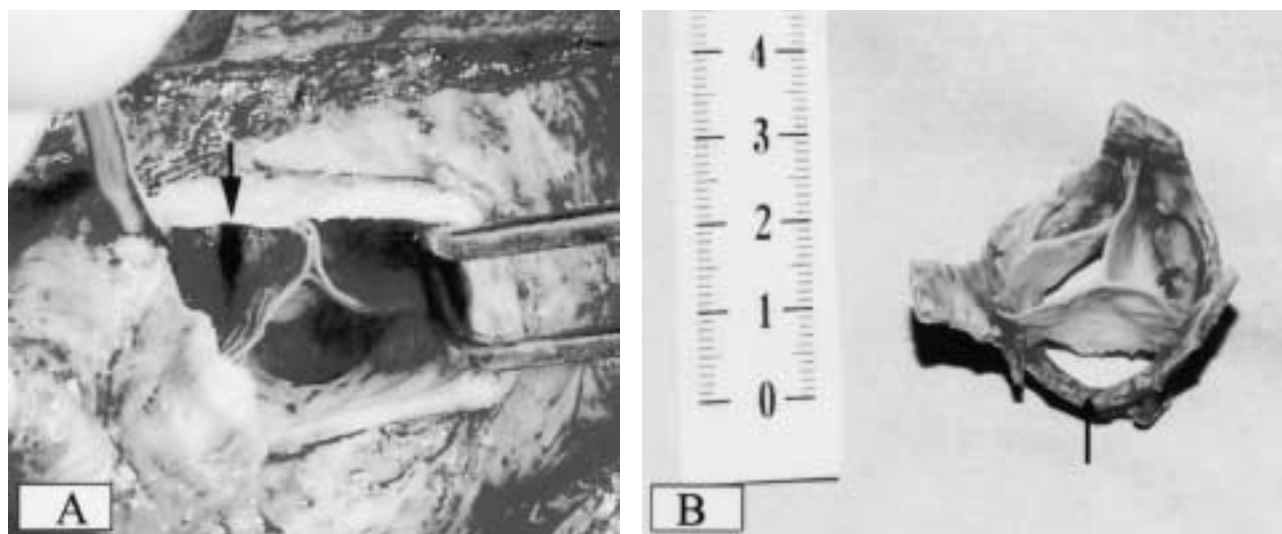
Fig. 1.

A: Intraoperative finding. The Freestyle's cusp positioned in the patient's left sinus showed a cuspal tear (arrow).
 B: Explanted Freestyle stentless bioprosthesis. Tear along the annulus in one of the cusps is observed (arrow).

tween the native and prosthetic coronary sinus was moderate and it was carefully separated down to the inflow suture line. No prosthetic dehiscence was observed. The prosthesis was excised after removal of the inflow suture. By direct observation, the Freestyle's cusp positioned at the patient's left sinus showed a tear along the annulus, which caused massive regurgitation. Every cusp was soft and mobile (Fig. 1).

Valve replacement was carried out with a No.21 bovine pericardial stented prosthesis. In a precise examination of the excised prosthesis, the findings of bacterial endocarditis and the other macroscopic changes including thrombus attachment and pannus formation were not observed in any of the 3 cusps. Cuspal calcific deposits, as examined through soft X-rays of the bioprosthesis, were additionally not found in any of the 3 cusps or in the aortic wall. Microscopic observation was performed afterwards to compare the torn cusp with the non-torn cusp. Normal thickness and corrugation with 3 layers was found in both cusps. One difference between these cusps was the quantity of elastic staining. The amount of elastic staining in the ventricularis layer was less in the torn cusp than in the non-torn cusp (Fig. 2).

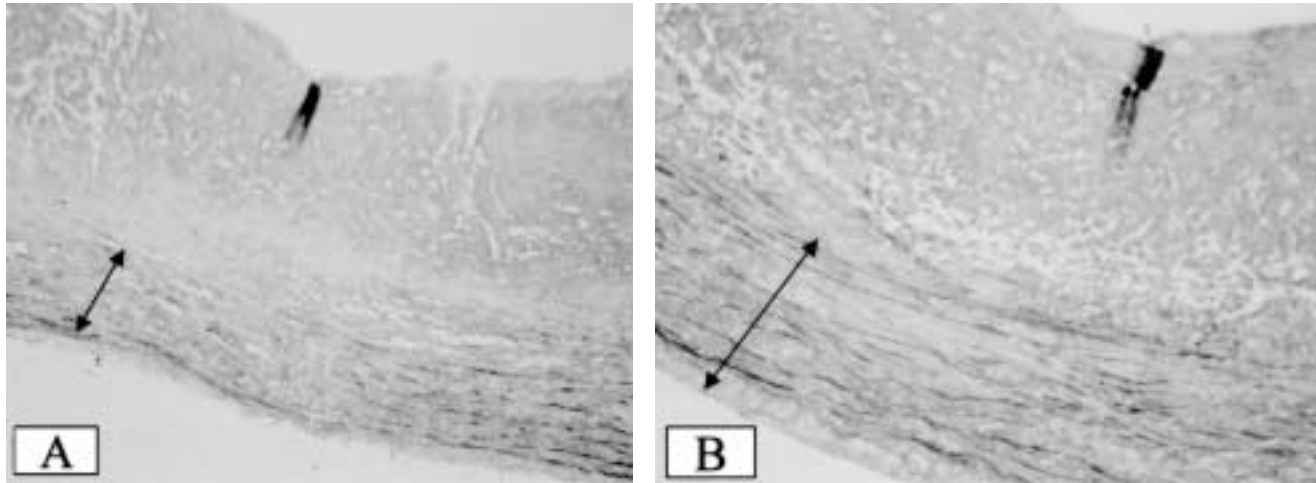
Fig. 2. Photomicrograph from a valve cusp. The amount of elastic staining in the ventricularis layer was less in the torn cusp (A) than in the non-torn cusp (B).

Arrow: showing the extent of the ventricularis layer (elastic stain, original magnification $\times 200$)

Fyfe⁶⁾ performed a pathological analysis of 67 removed Freestyle stentless bioprostheses with implant duration of up to 49 months. In his report, common microscopic alterations in a cusp were the loss of cuspal corrugation, and fibrosis of lamina spongiosa, and the loss of elastic tissue staining were also noticed as one of the basic microscopic alterations. In addition, he reported that calcification was rare and found only in the infected valve of 2 cases. With regard to the aortic wall, the degenerative change was minimal, and limited to focal loss of medial smooth muscle cells. We didn't observe these pathological findings except for some loss of the elastic fiber staining in the torn cusp.
