Re-do Mitral Valve Replacement Using the Valve-on-valve Technique: A Case Report

Key words: valve-on-valve technique, re-do mitral valve replacement

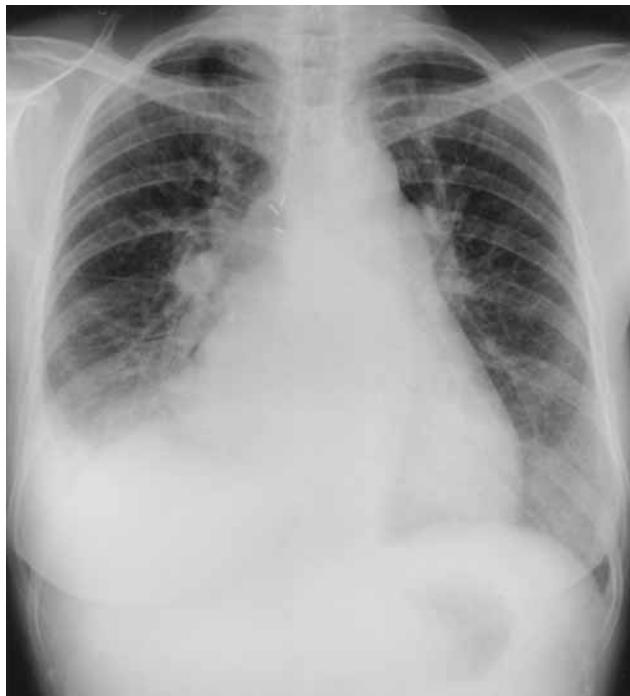
Fig. 1. Preoperative chest X-ray demonstrated cardiac enlargement with a cardiothoracic ratio of 0.65, and bilateral pleural effusion.

She presented with pulmonary edema and bilateral pleural effusions on chest X-ray, secondary to severe mitral bioprosthetic valve regurgitation (Fig. 1). Color Doppler echocardiography demonstrated a tear in a cusp due to degenerative changes in the mitral bioprosthesis without perivalvular leakage (Fig. 2). Cardiac catheterization demonstrated a pulmonary arterial pressure of 65/35 (mean 45) mmHg, and severe mitral regurgitation, and moderate tricuspid regurgitation.

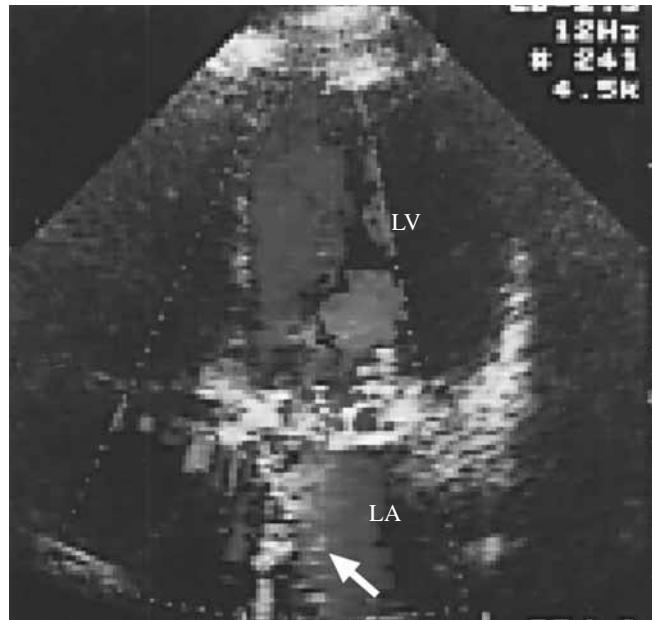
Fig. 2. Preoperative echocardiogram showed severe mitral regurgitation due to degenerative changes in the mitral bioprosthesis, and absence of perivalvular leakage (arrow).

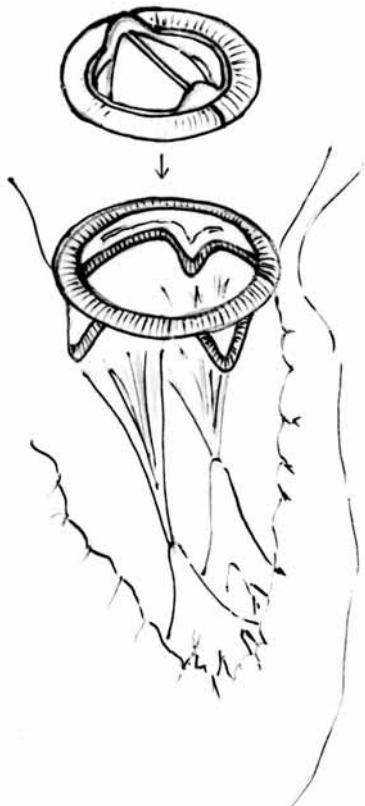
Fig. 3. Concept of the valve-on-valve technique. Only leaflet tissue is excised, and a mechanical prosthesis is attached to the old bioprosthetic valve annulus.

The valve-on-valve technique is a surgical option for replacement of a degenerated bioprosthesis with a mechanical bileaflet prosthesis. Only the degenerated tissue is excised, leaving the stent and supporting structure of the bioprosthesis intact; a new mechanical prosthesis is attached to the old bioprosthetic valve annulus (Fig. 3). This procedure is a simple technique that can avoid some of the complications associated with complete excision of the bioprosthetic valve.

From a technical point of view, a low profile mechanical bileaflet prosthesis is to be preferred, in order to avoid impingement of the disks on the bioprosthetic ring.⁴ In our case, we implanted an SJM prosthetic valve because its leaflets are hinged on the atrial side and only slightly protrude into the ventricular side.
