Re-do Mitral Valve Replacement Using the Valve-on-valve Technique: A Case Report

Key words: valve-on-valve technique, re-do mitral valve replacement

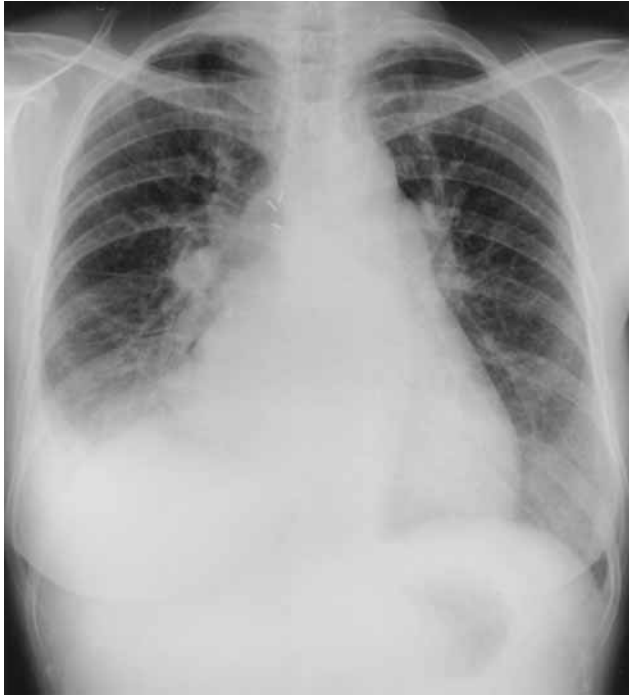
Fig. 1. Preoperative chest X-ray demonstrated cardiac enlargement with a cardiothoracic ratio of 0.65, and bilateral pleural effusion.

She presented with pulmonary edema and bilateral pleural effusions on chest X-ray, secondary to severe mitral bioprosthetic valve regurgitation (Fig. 1). Color Doppler echocardiography demonstrated a tear in a cusp due to degenerative changes in the mitral bioprosthesis without perivalvular leakage (Fig. 2). Cardiac catheterization demonstrated a pulmonary arterial pressure of 65/35 (mean 45) mmHg, and severe mitral regurgitation, and moderate tricuspid regurgitation.

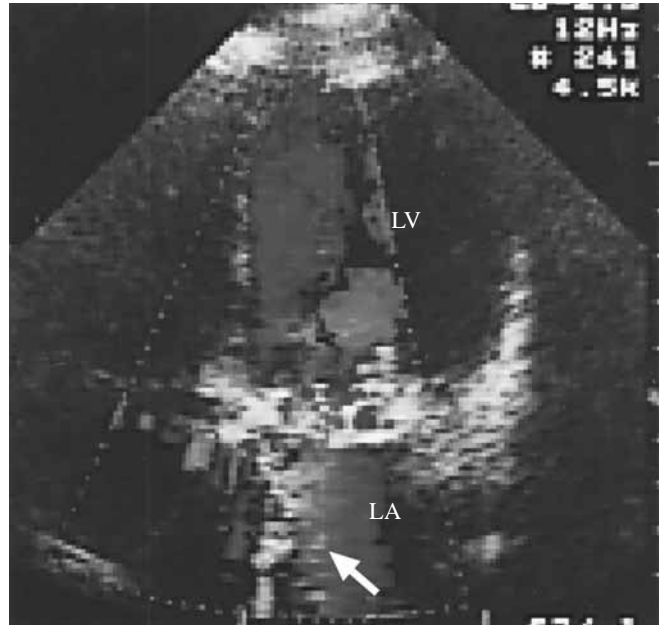
Fig. 2. Preoperative echocardiogram showed severe mitral regurgitation due to degenerative changes in the mitral bioprosthesis, and absence of perivalvular leakage (arrow).

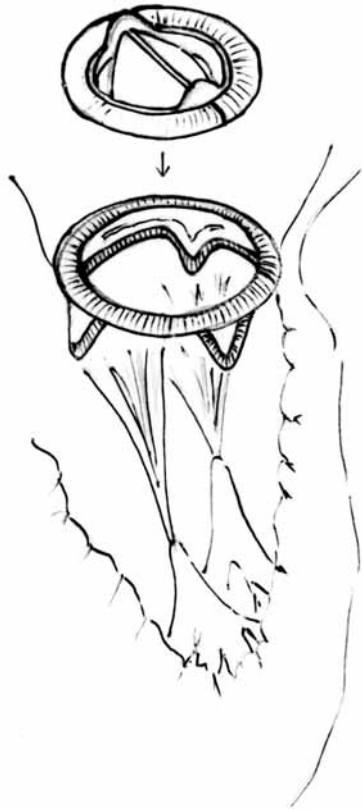
Fig. 3. Concept of the valve-on-valve technique. Only leaflet tissue is excised, and a mechanical prosthesis is attached to the old bioprosthetic valve annulus.

The valve-on-valve technique is a surgical option for replacement of a degenerated bioprosthesis with a mechanical bileaflet prosthesis. Only the degenerated tissue is excised, leaving the stent and supporting structure of the bioprosthesis intact; a new mechanical prosthesis is attached to the old bioprosthetic valve annulus (Fig. 3). This procedure is a simple technique that can avoid some of the complications associated with complete excision of the bioprosthesis.

From a technical point of view, a low profile mechanical bileaflet prosthesis is to be preferred, in order to avoid impingement of the disks on the bioprosthetic ring.⁴⁾ In our case, we implanted an SJM prosthetic valve because its leaflets are hinged on the atrial side and only slightly protrude into the ventricular side.
