# A Case of Mitral Valve Replacement with a Collar-reinforced Prosthetic Valve for Heavily Calcified Mitral Annulus

**Key words:** mitral regurgitation, mitral valve replacement, calcification of the mitral valve annulus, collar-reinforced prosthetic valve, Edwards MIRA prosthetic valve

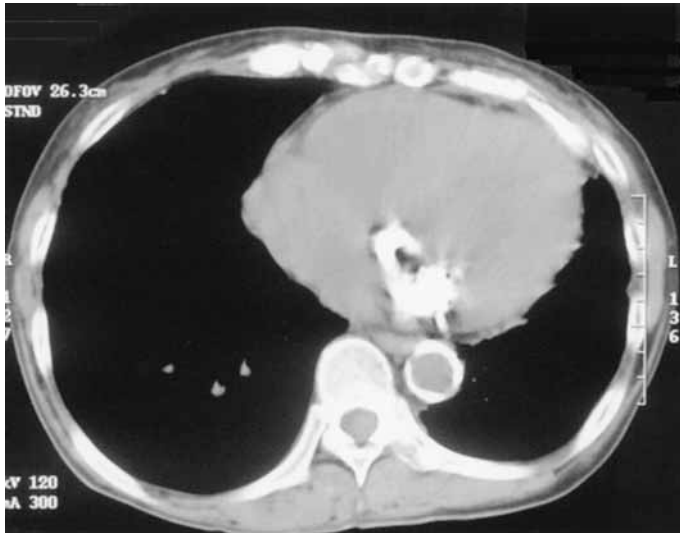
**Fig. 1.** Computed tomography scan demonstrated severe calcification of the mitral annulus.

Operation was performed through a median sternotomy. Cardiopulmonary bypass was instituted via right atrial venous and ascending aortic cannulas. A left ventricular venting tube was inserted through the right superior pulmonary vein. After cardioplegic arrest, exposure was obtained through a left atriotomy. The posterior mitral annulus was found to have been replaced with a mass of calcium, which extended into the ventricular cavity below the leaflet. The annulus of the anterior leaflet was less involved and pliable, and the valve leaflets themselves

were thickened but not calcified. The anterior leaflet was removed; nothing was excised from the posterior leaflet or the intramural block of calcium. A 23-mm Edwards MIRA prosthetic valve (Edwards Lifesciences LLC, Irvine, CA, USA) modified by enlarging the circumference of the sewing ring by the attachment of a 1.5 cm wide equine pericardial collar (Equine Pericardial Patch; Edwards Lifesciences LLC, Irvine, CA, USA) (Fig. 2) was secured with 2-0 polyester pledgeted mattress sutures placed through the posterior leaflet tissue from the left ventricle to the left atrium and then passed through the sewing ring of the composite valve. No sutures were placed through the calcified posterior annulus, but the anterior annulus was incorporated where suitable. After tying the mattress sutures, the free edge of equine pericardial collar was sutured to the atrial wall with a running 4-0 polypropylene suture (Fig. 3). The aortic valve was replaced with a 19-mm SJM prosthetic valve (St. Jude Medical Inc., St. Paul, MN, USA) in the usual fashion. The patient was smoothly weaned from cardiopulmonary bypass and intraoperative echocardiogram examination confirmed satisfactory valve function. The duration of cardiopulmonary bypass and aortic cross clamp was 227 min and 173 min, respectively. The postoperative course was uneventful and the patient was discharged on the 22nd postoperative day. The patient has been doing well for 16 months postoperatively without evidence of periprosthetic leakage.

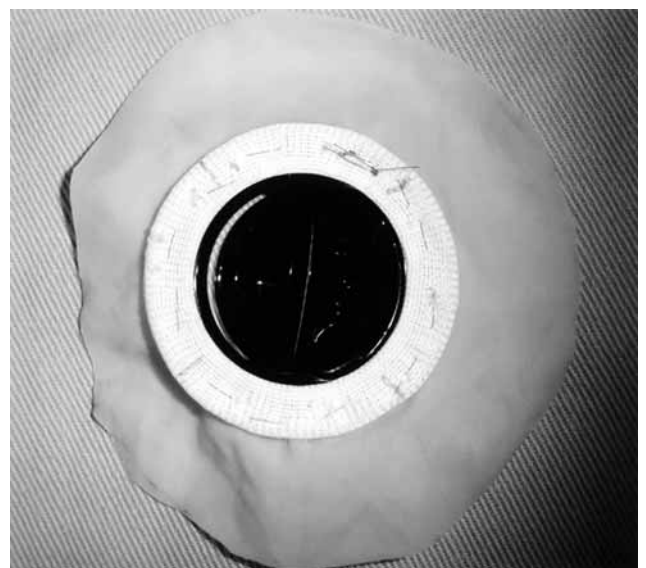
**Fig. 2.** A 1.5 cm wide equine pericardial collar has been sewn to the sewing ring of a 23-mm Edwards MIRA prosthetic valve.

We chose the Edwards MIRA prosthetic valve because of its hyperbolic shape and compressibility of the sewing ring that permits conformation to irregularities of the highly calcified annulus, reducing the possibility of perivalvular leakage.

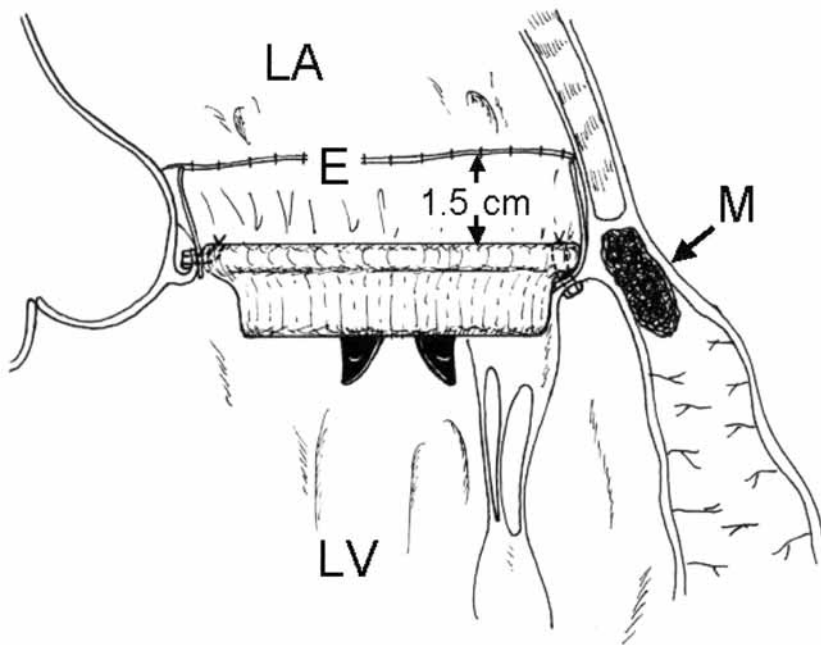
**Fig. 3.** A collar-reinforced Edwards MIRA prosthetic valve was secured with 2-0 polyester pledgeted mattress sutures placed through the posterior leaflet tissue from the left ventricle to the left atrium and then passed through the sewing ring of the composite valve. The free edge of equine pericardial collar was sutured to the atrial wall with a running 4-0 polypropylene suture. LA, Left atrium; LV, left ventricle; M, mitral annular calcification; E, equine pericardial patch.

through a linear fracture in the leaflet at the site of needle penetration. The technique we describe here is a combination of these two procedures. It facilitates to avoid the risk of decalcification described above and to disperse the hemodynamic stress. The height of the collar of the valved conduit allows atrial anchorage of the sewing ring and protection against a hemodynamically significant perivalvular leakage.
