# Repair of Ventricular Septal Perforation with Asymmetrical Conical Patch Exclusion

**We report a case of repair of the postinfarction ventricular septal perforation (VSP), using an equine pericardium tailored in an asymmetrical conical shape for exclusion (modified sack technique) and an additional direct patch closure of VSP. An asymmetrical conical patch is easily sutured to the normal septum away from the VSP edge by using the longer part of the cone border. The postoperative left ventriculogram 1.5 months after surgery revealed a minor leakage from the patch to the excluded left ventricle. However, no residual left to the right shunt was found in calculation from the oxygen saturation in blood samples. Echocardiography 1 year after surgery showed no residual patch leakage at all. We suggest that this modified sack technique is a simple and easy method by which to exclude the VSP. (*Ann Thorac Cardiovasc Surg* 2008; 14: 192–195)**

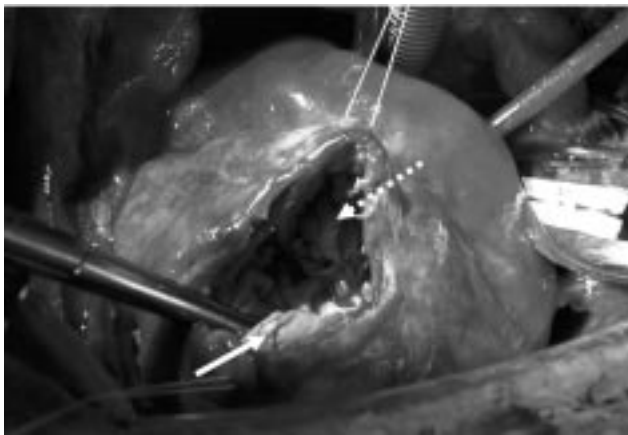
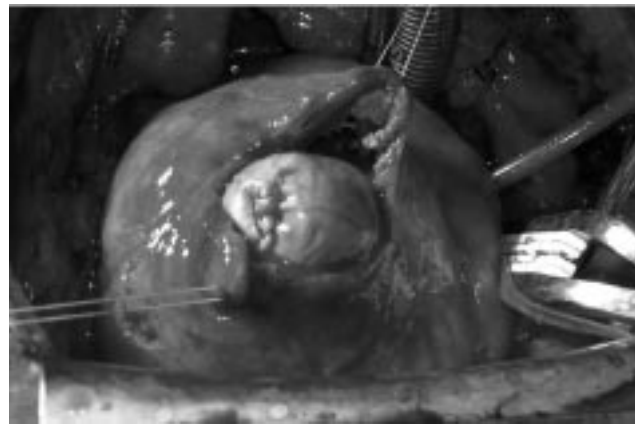
**Fig. 2.** Intraoperative view. Left: White arrow shows an asymmetrical conical patch. The white dotted arrow shows the VSP patch. Right: Expanded conical patch. The patch was expanded well and close to left ventricular apex.

conical sack. Four 3-0 polypropylene stay sutures with Teflon felt pledgets were placed. Two “U” stay sutures were placed on the healthy endocardium proximal to the infarct in the septum, and the remaining two were brought outside the lateral ventricle wall. These sutures were then run through the base of the conical patch. An asymmetrical conical patch can then be easily sutured to the normal endocardium in the septum by using the longer portion of the cone border. The equine pericardium was lowered into the ventricular cavity, and the four stay sutures were knotted. Continuous running sutures were placed between the knots (Fig. 1A). After the exclusion procedure, the VSP was closed with the pericardial patch by six 4-0 polypropylene interrupted sutures. The myocardium around the VSP was still fragile. Therefore the interrupted suture was tied gently (Fig. 2, top). The pericardial patch was inflated with the cardioplegic solution to examine its size and shape after all procedures were finished (Fig. 2, bottom). The left ventriculotomy was closed with a buttressed suture (2-0 Ticron suture) on a Teflon felt strip. No additional coronary bypass grafting was performed. The bypass and aortic cross-clamp times were 195 and 102 min, respectively.

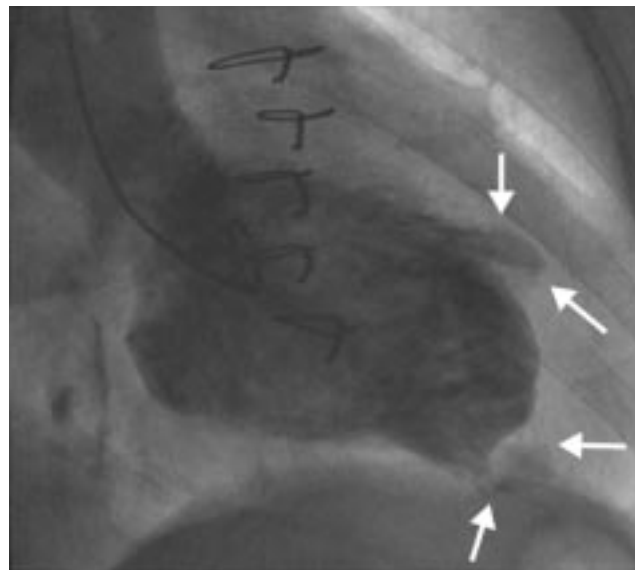
**Fig. 3.** Postoperative left ventriculogram. Spherical shape of the left ventricular apex was seen with minor leakage from the patch (white arrow).

out difficulty. The IABP was removed on postoperative day 2. A postoperative left ventriculogram 1.5 months after surgery revealed minor leakage (Fig. 3). However, no residual left-to-right shunt was found by calculation from oxygen saturation in blood samples. Echocardiography 1 year after surgery showed no residual leakage. The patient remains in good health to date at 13 months after surgery.

The asymmetrical conical patch we made had a 5-cm long border and a 3-cm short border and was 7 cm in diameter. The procedure was carried out smoothly, and the postoperative course was uneventful. The postoperative left ventriculogram 1.5 months after surgery revealed a minor leakage. Fortunately, no residual left-to-right shunt was found in calculation from oxygen saturation in the blood samples. This suggests that the patch that closed the VSP avoided a left-to-right shunt, and it also facili-
